Gully Erosion in Anambra State, South East Nigeria: Issues and Solution

Obiadi. I.I, Nwosu.C.M., Ajaegwu.N.E, Anakwuba.E.K, Onuigbo.N.E, Akpunonu.E.O,
Ezim.O.E.

Geological Sciences Department, Nnamdi Azikiwe University, Awka, Nigeria.

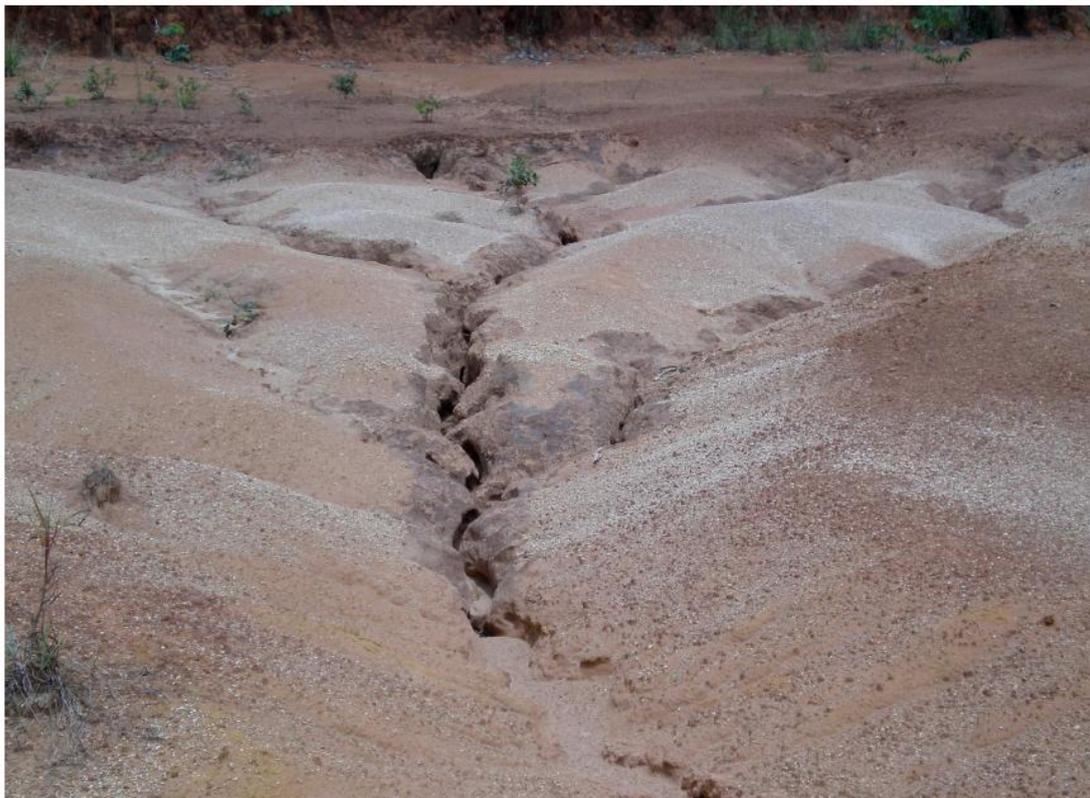
Figure 5: Onset of gully erosion triggered by deforestation and topsoil excavation.

The hydrogeochemical characteristics of the area are also important factors in the development and growth of gullies by way of chemical weathering (Egboka et. al. 1983). The surface and groundwater are slightly acidic, thereby facilitating the decomposition of the cements binding the rock particles together and making them vulnerable to erosion by mass wasting and excess runoff (Egboka and Okpoko, 1984). This same acidic water attack and disintegrate dams and other civil engineering works put in place to control the hazard. Human interference with the natural geologic system has also compounded issues. Most of the erosion sites are around small towns and villages that are well populated. Available lands are put to use for farming and construction works, most of which are without proper design. This leads to blockage/change in the natural water channel ways, concentration of excess runoff with high velocity and eroding potential. Deforestation, a common practice in Anambra State, exposes the soils and rocks to severe gulling (figure 5)

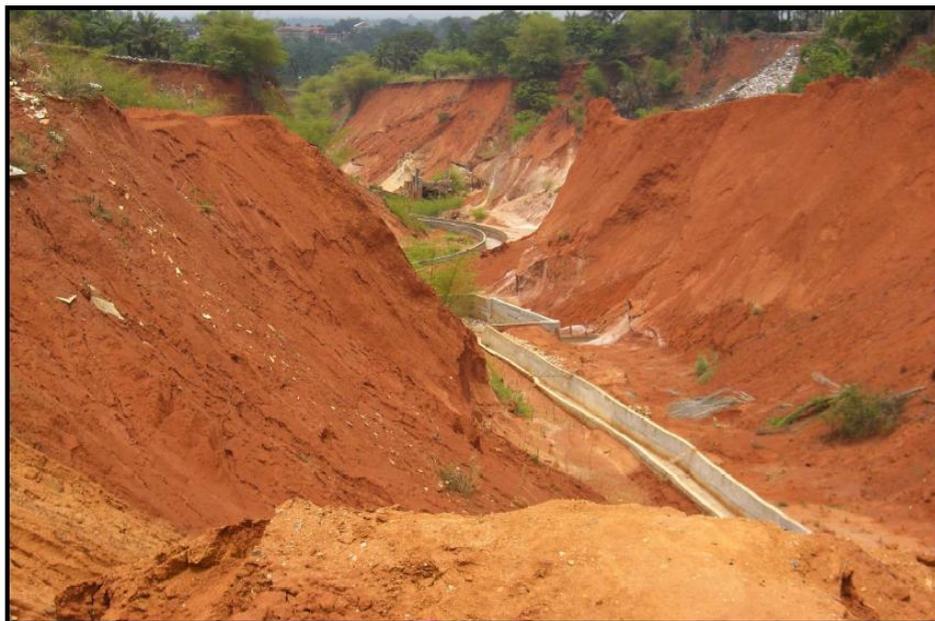
Figure 6: Control measure put in place to check gully erosion.

Gulling has persisted despite efforts by the federal government, state governing, local government, towns/community unions as well as individuals. In towns like Nanka, Nkpologwu, Agulu-Ezechukwu, Ekwulobia and Agulu, the gully extends for kilometers with width and depth in tens and hundreds of meter (table 1). Generally most of the gully sites investigated are still very active despite the control measures already in place. In Ekwulobia for example, the mass of rock, pavement, culvert and Bamboo trees used for the control of the gully was observed right at the base of the gully channel obviously dislodged by sliding. Massive civil construction works to contain the menace is on-going at the site and other sites visited (figure 6).

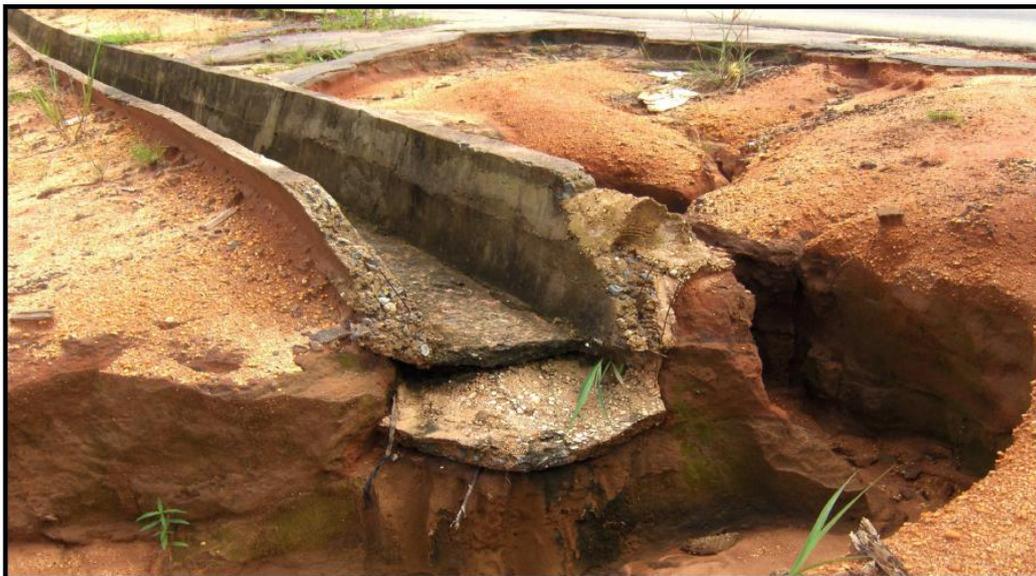
Figure 7: Improper termination of drainage channel forming gully erosion triggers.
