Performance Evaluation of Protective Coatings on Corrosion resistance in Transmission Line Tower foundations

R.Siva Chidambaram* Dr.G.S.Thirugnanam***

*- Post Graduate student-IRTT,Erode ***- Guide- Head & Professor in civil
Engg/IRTT/Erode.

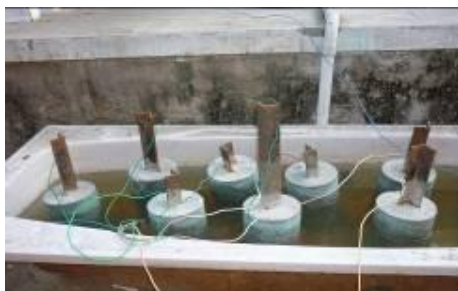
Fig :9: Corrosion Acceleration(Before Corrosion) Fig :10 FACSR Coated Angle

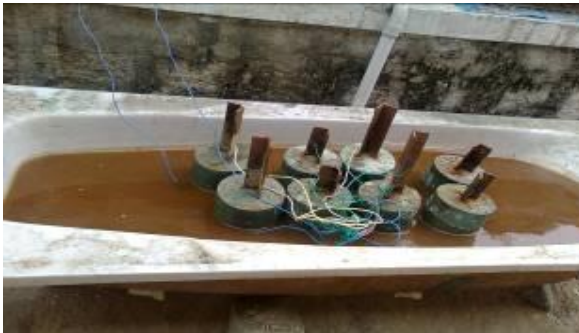
Fig :11 Accelerated Corrosion(After Corrosion) Fig:12 FACSR Coating Technique

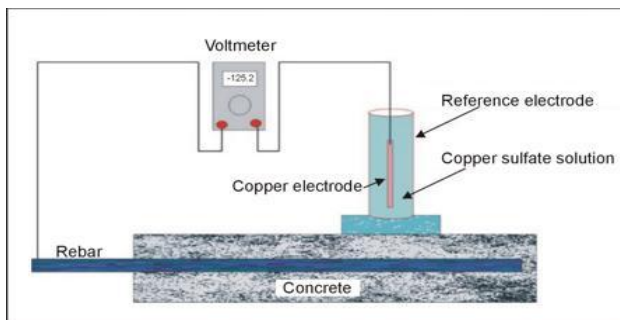
Fig:11 Half Cell test Set up

The half-cell is a hollow tube containing a copper electrode and immersed in copper sulfate solution. The bottom of the tube is porous and is covered in a sponge material. The copper sulfate permeates this sponge that can then be placed on a concrete surface allowing an electrical potential (voltage) to be measured. The objective of the method is to measure

the voltage difference between the rebar and the concrete over the rebar. Large negative voltages (-350mV) indicate that corrosion may be taking place. Voltages smaller than about -200 mV generally mean corrosion is not taking place.

Half cell potentiometer readings were taken on specimen every 50 hours. The experimental set up is as shown in the figure11 . Table 1 and Figure14,15 shows the variations of half cell potentiometer readings with accelerated time.

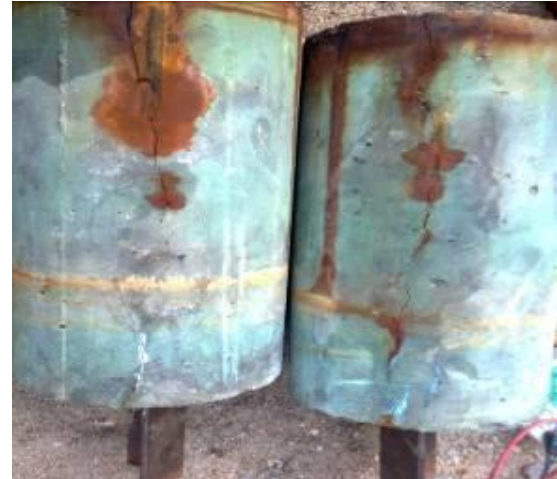
Fig:15: Half Cell potential Value Comparison

Fig : 16: Cracked Specimen

Figure 16 shows that , the crack propagation which occurred in Corrosion inhibitor mixed concrete specimen. The Specimen get cracked after 280 hrs.

The **Figure14,15**, shows the Time vs corrosion potential behavior of coated specimens in the Half CellPotentiometer test. It can be seen that there is a reduction in corrosion potential for Flexibond ACSR coated specimens compared to other specimens. This observation is due to a higher resistance of these coating materials against chloride ingress. The longer initiation period of Flexibond ACSR Coating is due to the Barrier nature of the Coating.

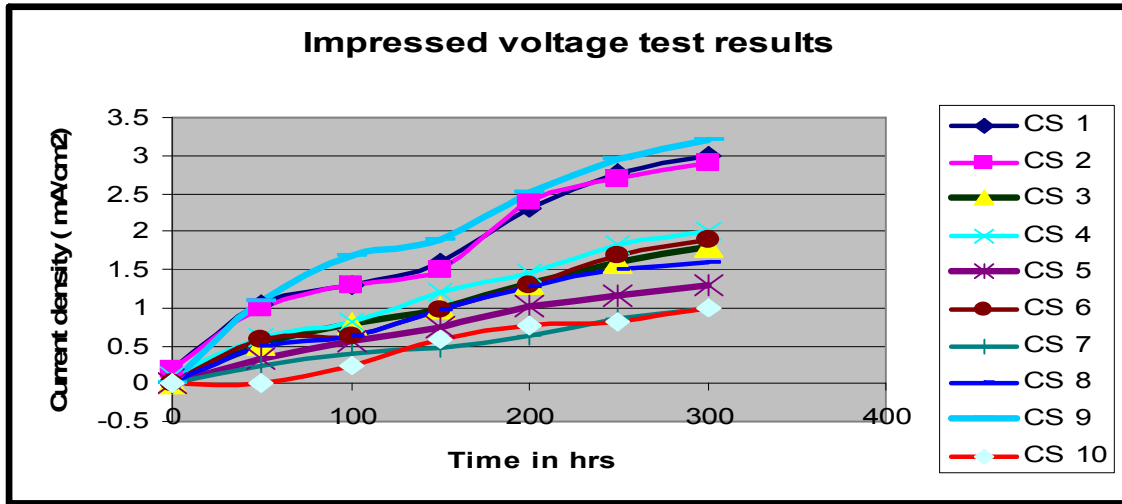
Fig:17: – Current Density Value of 10 Specimens

The Figure 17,18, shows the Time vs Current density behavior of coated specimens in the impressed voltage test. It can be seen that there is a reduction in current density for coated specimens compared to other specimens. This observation is due to a higher resistance of these coating materials against chloride ingress. The longer initiation period of Flexibond ACSR Coating is due to the

Barrier nature of the Coating. Incase of Un coated specimens as well as uncoated angles and Corrosion Inhibitors mixed specimens current density values are high when compared with (three Level Coating) Flexibond ACSR Coating.

Impressed Voltage readings were taken on specimen every 50 hours upto 300 hrs.**Table 2 and Fig 17,18,,** shows the variations of Impressed Voltage readings with accelerated time
