Experimental Investigation on Behavior of Reinforced Concrete Beam Column Joints Retrofitted with GFRP-AFRP Hybrid Wrapping

Robert Ravi.S¹, Prince Arulraj.G²

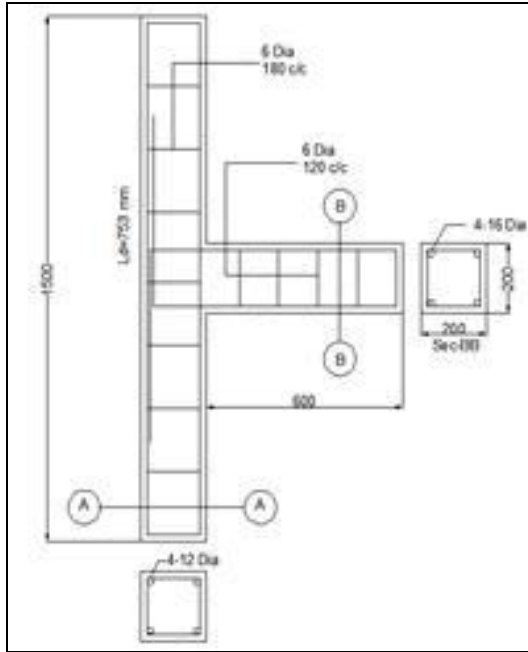
Figure 1.a: Reinforcement Details for Specimen as per code IS 456:2000

The experimental program consisted of testing three reinforced concrete beam-column joint specimens named as C1, C2 and C3 . Specimens C1 and C2 had reinforcement details as per code IS 456:2000. Specimen C3 had reinforcement details as per code IS 13920:1993. The columns had a cross section of 200 mm x 200 mm with an overall length of 1500 mm and the beams had a cross section of 200 mm x 200 mm with a cantilevered portion of length 600 mm. The column portion was reinforced with 4 numbers of 12mm diameter rods and the beam portion was reinforced with 2 numbers of 16 mm diameter rods at tension and compression zones. The lateral ties in the columns of the specimens C1 and C2 were 6 mm diameter bars with the spacing of 180 mm c/c as per code IS 456:2000, cl 26.5.3.2(c). Beam had vertical stirrups of 6 mm diameter bar at 120 mm c/c as per code IS 456:2000, cl.26.5.1.6. The development length of the tension and compression rods in beam were also provided as per clause 26.2.1 of code IS 456:2000. The lateral ties in the columns of the specimens C3 consisted of 8 mm diameter bar at 75 mm c/c for the central distance of 1100 mm as per code IS 13920:1993, cl 7.4.6 and 6mm diameter bars at 100 mm c/c for the remaining length of the column. Beams had vertical stirrups of 6 mm diameter bar at 40 mm c/c. up to a distance of 340 mm from the face of the column as per code IS 13920:1993, cl 6.3.5 and 6 mm diameter bar at 80 mm c/c for remaining length of the beam. The development length of the beam rods were also provided as per code IS 13920:1993, cl 6.2.5. The concrete mix was designed for a target strength of 20 MPa at the age of 28 days. The load carrying capacity of the column was estimated to be 440 kN. The details of the test specimens are given in Figure.1 (a) & Figure.1 (b). The load reversal (push and pull) tests were conducted on the control and retrofitted reinforced concrete beam-column joint specimens. Generally, when the axial load on the column exceeds 50 to 60% of its capacity, the effect of axial load will be more predominant on the joint. In the case of the seismic forces, the effect of lateral load will be more predominant. Hence in order to truly reflect the behavior of the joint under seismic load conditions, it was decided to restrict the axial loads of column to a maximum of 200 kN which is less than 50 % of load carrying capacity of the column. A point load was applied at the free end of the cantilever beam portion till the failure of the specimen. The loading was continued till the joint failed by crushing of concrete in the case of control specimens and by the rupture of wrap in the case of retrofitted specimens. The failed specimens C1 and C2 were retrofitted with hybrid wrapping sheets. The specimen C1 had GFRP sheet as inner layer and AFRP sheet as outer layer. The specimen C2 had AFRP sheet as inner layer and GFRP sheet as outer layer. The specimens were redesignated as retrofitted specimens R1 & R2 and again tested to failure.

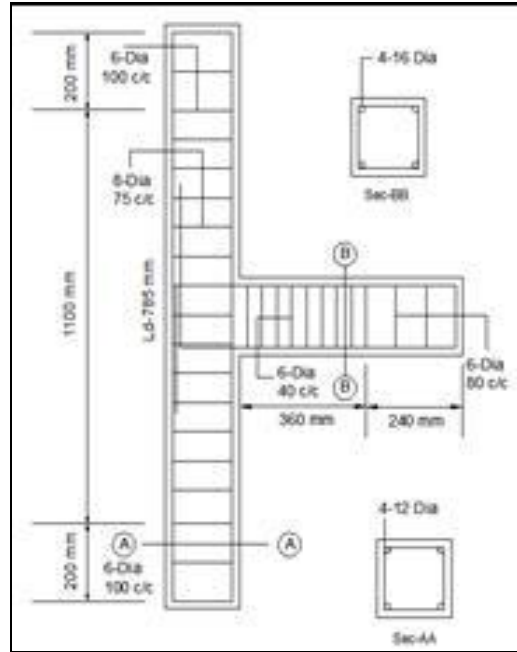
Figure 1.b: Reinforcement Details for Specimen as per code IS 13920:1993

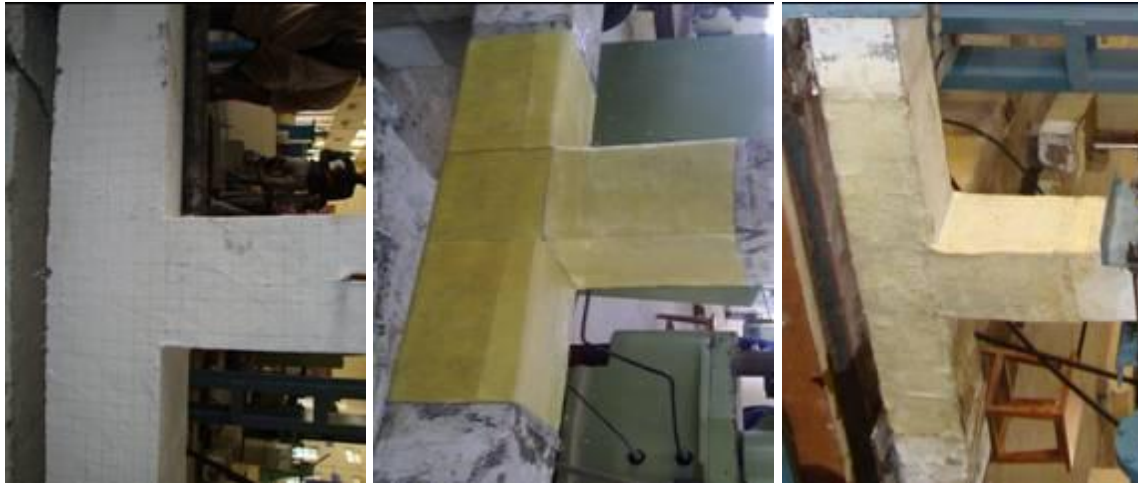
Figure.2a: Typical view of Control Specimen

Figure.2b: Typical view of GFRP -AFRP Specimen

Figure.2c: Typical view of AFRP-GFRP specimen

1:1.57:2.97 with the w/c ratio of 0.49. Concrete was mixed in a tilting type mixer machine and was properly placed and compacted. The sides of the mould were removed 24 hours after casting and the test specimens were cured in water for 28 days. The failed specimens C1&C2 were retrofitted and redesignated as specimens R1&R2. The concrete near the area of failure was removed completely. After applying cement paste in this area, the portion was filled and compacted with the same grade of concrete. The specimens were cured for 28 days. Before wrapping fiber sheet, the faces of the specimens were ground mechanically to remove the laitance. All the voids were filled with putty. Then a two component primer system was applied on the concrete surface and allowed to cure for 24 hours. A two component epoxy coating was then applied on the primer coated surface and inner layer of fiber sheet was immediately wrapped over the entire surface of the reinforced concrete beam-column joint. A hand roller was then applied gently over the wrap so that good adhesion was achieved between the concrete surface and allowed to cure for seven days. Another coat of the two component epoxy was applied over the inner layer of fiber sheet. Then the outer layer of wrap was applied following the same procedure and allowed to cure for a further period of seven days. Both the wrapped layers were orthogonal to each other. Figure .2 a) Figure. 2 b) & Figure.2 c) show the typical control and retrofitted specimens.

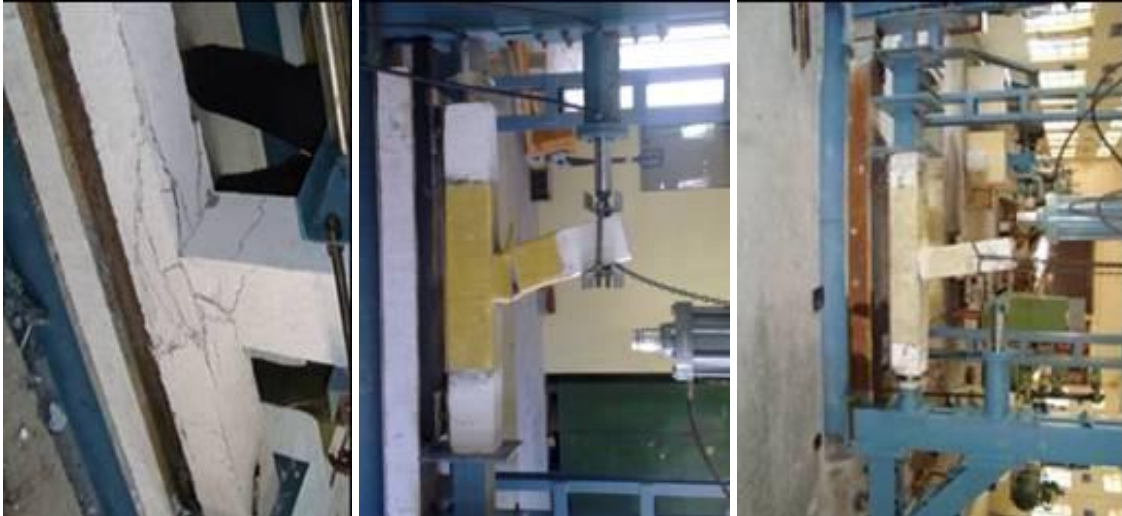
Figure 3.a: Typical view of failed Control Specimen **Figure 3.b:** Typical view of failed(GFRP-AFRP)Specimen **Figure 3.c:** Typical view of failed(AFRP-GFRP)Specimen

load cell. The deflection at the free end of the beam was recorded at regular load intervals up to a control deflection of 50 mm. The retrofitted specimens R1 & R2 were also tested following the same procedure. Figure 3.a), Figure 3.b) & Figure 3.c) show the typical view of the failed control and retrofitted specimens.

- The failure was in the column portion of the joint for the control specimen which is to be avoided. In the case of the wrapped specimens, the failure was noticed in the beam portion only and the column was intact and this is the most preferred type of failure under seismic loads which will prevent progressive collapse of the structure.

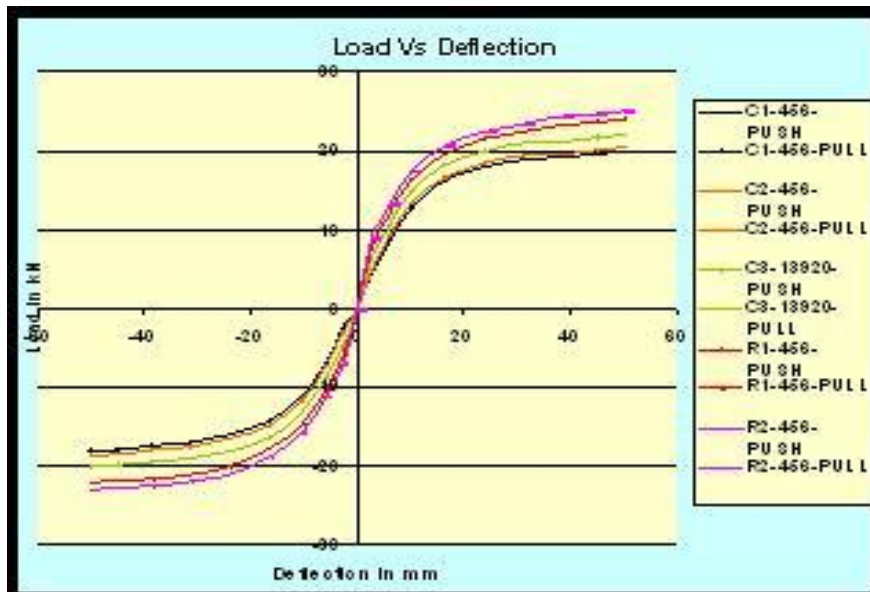
Figure.4 Load Deflection Curve for Control and Retrofitted Specimens

In the case of the specimen R2, during pushing, first crack was formed in the beam portion approximately at a distance of 40 mm from face of the column at a load of 19.5 kN. At a load of 20.5 kN, another crack was formed in the beam-column joint of the test specimen. The cracks in the beam started to widen at a load of 21.5 kN. Spalling of concrete occurred in the tension zone of the beam at a load of 23 kN. The application of the load was stopped when the deflection at the free end of the beam reached 50 mm. The load corresponding to this deflection was 24.3 kN. During pulling, first crack was formed in the beam portion at a load of 17.5 kN. At a load of 18.5 kN, another crack was formed in the beam-column joint of the test specimen. The cracks in the beam started to widen at a load of 19.5 kN. Spalling of concrete occurred in the tension zone of the beam at a load of 20.5 kN. The application of the load was stopped when the deflection at the free end of the beam reached 50 mm. The load corresponding to this deflection was 22.3 kN. The load deflection curves of control & GFRP-AFRP/AFRP-GFRP wrapped reinforced concrete beam-column joint specimens are shown in Figure.4 The load carrying capacity

It is seen from the Table. 2 that the load carrying capacity of the beam-column specimen retrofitted with GFRP-AFRP/AFRP-GFRP hybrid sheet increased about 21.5 % during pushing and 23.8 % during pulling. The area of the load-deflection curve up to the limiting deflection increased by 28.9 % for the beam-column specimen retrofitted with GFRP-AFRP/AFRP-GFRP hybrid sheet during pushing and 33.2 % during pulling. The load deformation characteristics also improved to a larger extent in the case of wrapped specimens over the control specimens. This resulted in a substantial increase in the energy absorption characteristics of the specimens that were wrapped with GFRP-AFRP/AFRP-GFRP sheet.
